# **quinquennial inspection**

## **church of st guthlac • leicester**

**pcc of st guthlac • leicester**  
date of inspection: 25 october 2019

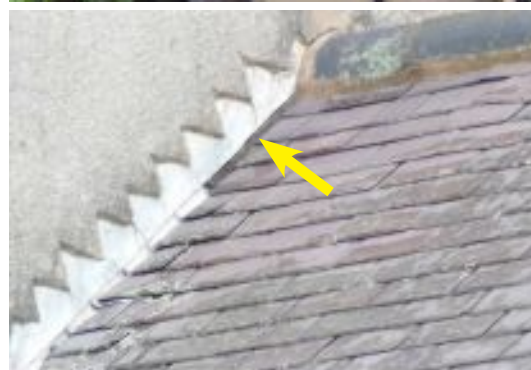
Top: Chancel, south slope. Above: Flashings to the bellcote with possible missing soakers. Below: View of the bellcote.

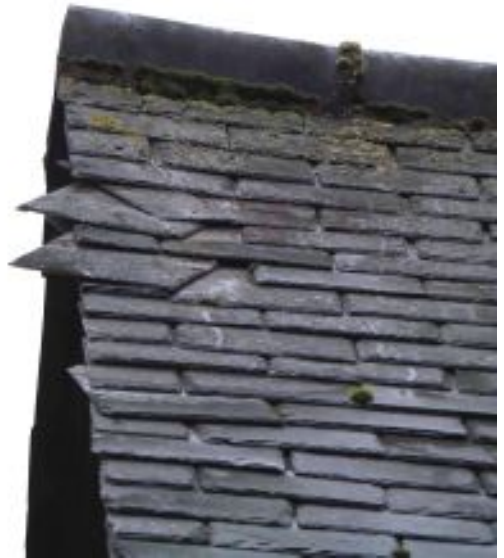
- i The roof is of Welsh slates, which are in a generally good condition apart from the eaves at the east end where there are 5-8 slates that are displaced at the eastern eaves, which need to be re-positioned and re-fixed and are currently out of place.
- ii The flashings to the bellcote and the weathering to the calling bell rope entry, all appear to be in a good condition, although the bell rope is missing.
- iii The lightning conductor down tape is clipped to the bellcote wall and to the roof of the south slope of the chancel and is in a good condition.

*Above: Displaced slates to the east end of the chancel north slope. Below: Clergy vestry/boiler room, east slope. Second below: Displaced slates to the north east corner eaves. Bottom: Clergy vestry, west slope and valley gutter.*

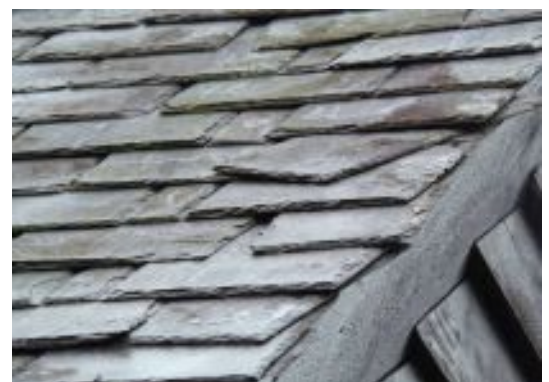
- i The roof is of Welsh slates, which are in a good condition.
- ii There is damp staining against the abutment with the north wall where the water discharges from the chancel roof but this appears to be watertight.
- iii The north east corner of the roof has 2 slates at the eaves that are displaced and should be re-fixed to preserve the integrity of the roof covering. There are also a number of slates higher up the roof at the northern gable that are displaced and also need to be re-fixed.

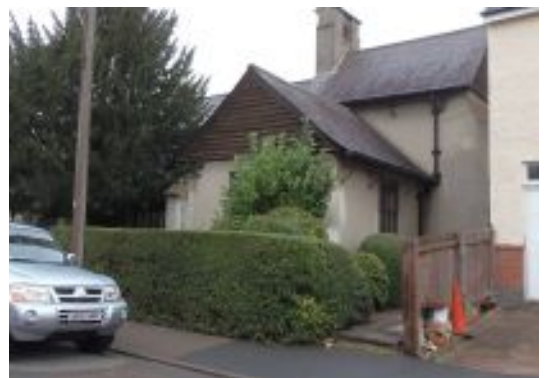
- i The roof is of natural Welsh slates, which are in a generally good condition. One slate is noted to be missing to a corner section and there is one slightly displaced slate towards the central portion of the roof and one missing slate towards the west end of the roof, approximately 3 slates in and 10 courses up and this does need to be replaced quite urgently. There are also 2 ventilation openings, which appear to be redundant and ideally should be replaced when any work is done to the roof but otherwise the roof is in a good condition.
- ii The ridge tiles have a lack of mortar pointing to the tiles of the western 5m and ideally these should be re-bedded, particularly if there is any further sign of movement.

Top: Nave, north slope. Above: Missing slate to the western end of the nave north slope. Below: Nave, south slope. Second below: View of the choir vestry and roof. Bottom: East slope of the choir vestry roof and guttering.

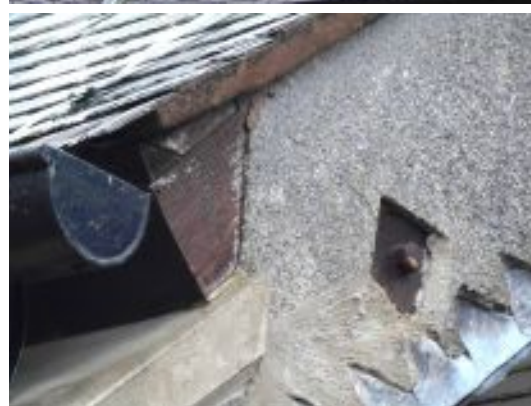
*Above: Clergy vestry, north elevation. Below: Chancel, west elevation. Second below: Rusting pattress plate in the chancel, west elevation. Bottom: Link corridor west elevation plinth.*

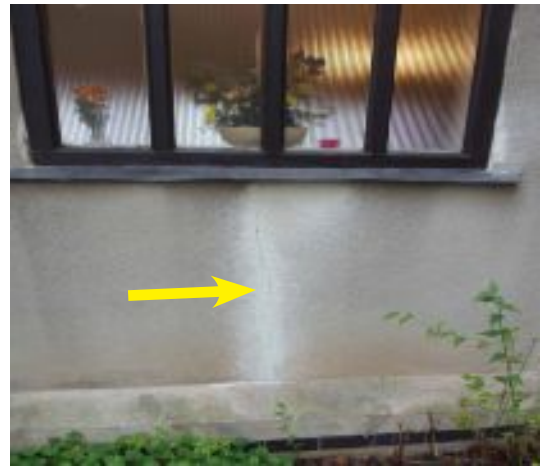
*Above: Slight crack below the window in the 5th bay of the nave south elevation. Below: Choir vestry, west elevation. Second below: Crack above the window in the choir vestry east elevation. Bottom: View of the timber south porch.*

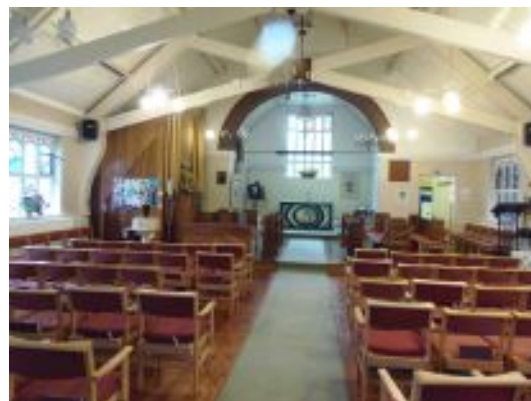
*Above: Altar platform and chancel step. Below: Choir platform, which has some soft patching. Second below: Nave interior looking east. Bottom: Choir vestry interior.*

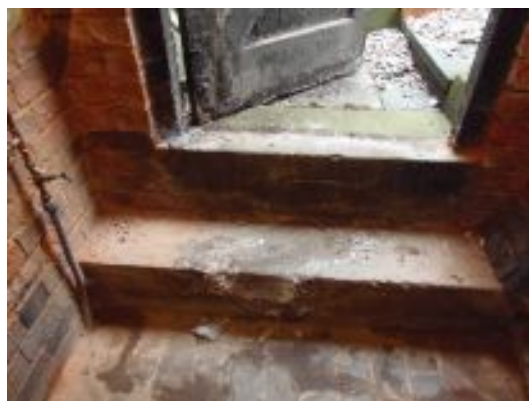
Above: Boiler room floor with some damp. Below: Boiler room steps. Second below: Hardwood entrance door within the porch. Bottom: Chancel north wall through to the vestry.

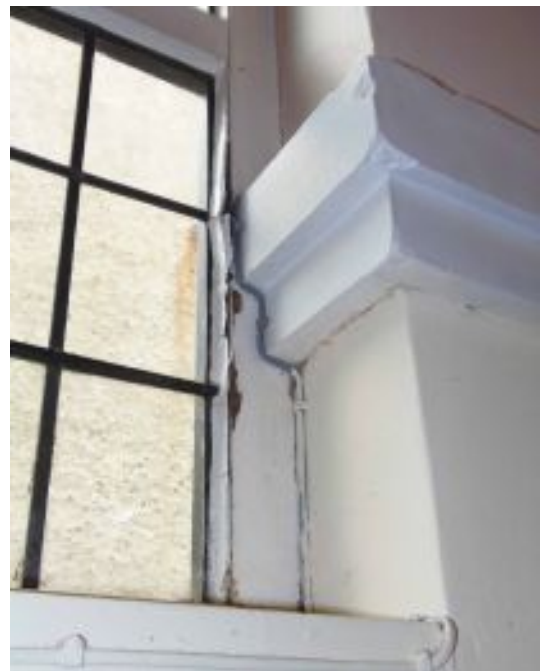
*Above: Putty failing to the east window frame in the chancel. Below: View of the chancel, east wall. Second below: Chancel, south wall. Bottom: Nave north wall, 2nd bay from west.*

and 5 sub-lights below the window with 3 hopper windows at high level with steel frames, all with leaded glass. The window frames appear to be in a good condition, as does the glazing. There appears to be some deterioration of the putty holding the window glazing in place and this is particularly evident to the north and south sides of the window frames, although the majority of the lower lights appear to be affected. Ideally the putty should be replaced and the windows redecorated.

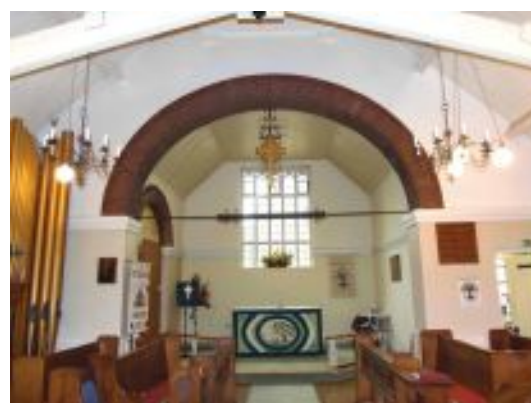
v There is further cracking to the stringcourse immediately above the window opening but this is less than 1mm wide and should be monitored for further development.

*Above: Cracking above the western window in the nave north wall. Below: Nave, east wall and chancel arch. Second below: Plaster damage to the north of the chancel arch. Third below: Nave, south wall. Bottom: Cracking above the eastern window on the nave south wall.*

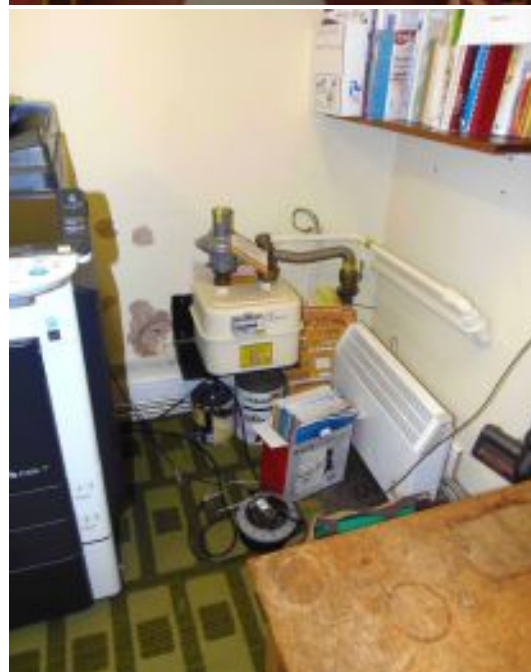
*Above: Nave south wall, western window. Below: Nave, east wall. Second below: Nave, east wall looking through to the porch. Bottom: Choir vestry north wall with some plaster damage.*

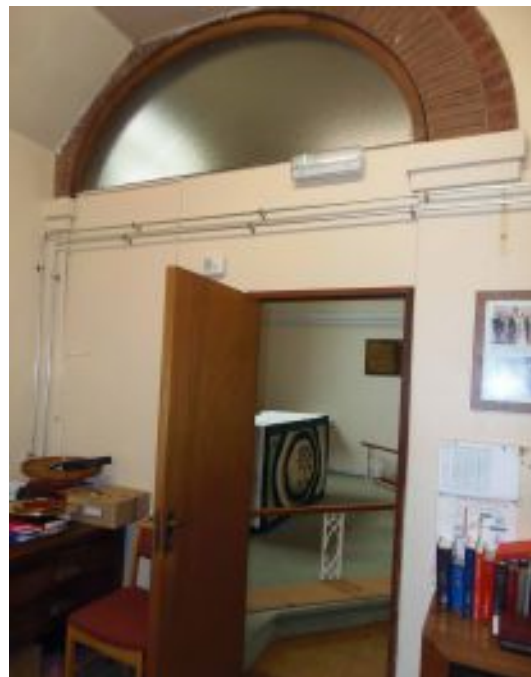
- i The walls are of brickwork and this is in a good condition. There is an open cavity where the flue penetrated the chimney but otherwise this is in a good condition.
- ii At low level there is also a cavity, possibly a coal hole but this is not clear.
- iv The pipework of the fittings within the boiler room is not insulated. It would be beneficial and would protect the room against damage due to frost if the system is ever turned off.
- v The base of the door exhibits minor rot and has expanded slightly and ideally should be adjusted to open and close more effectively.

*Above: Clergy vestry south wall, door through to the chancel.  
Below: Boiler room wall with cavity and un-insulated pipework. Bottom: Boiler room door.*

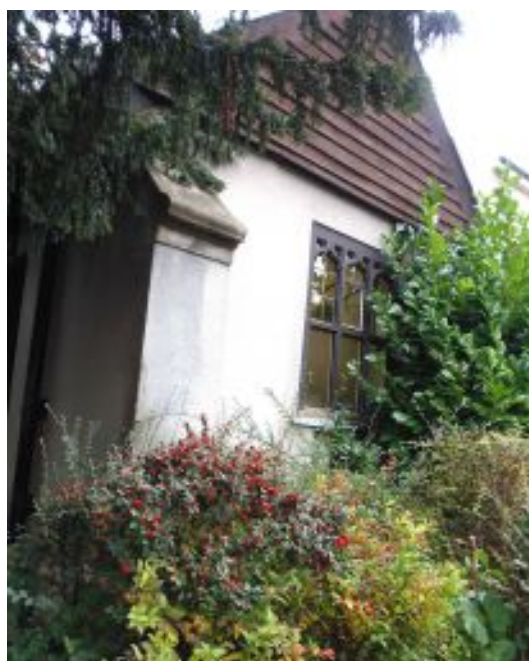
Externally the east boundary fence is in a poor condition and needs either to be repaired or replaced. The trees to the east side of the church need to be pruned to ensure that they do

*Above: Paved area to west of the church. Below: View of the entrance path to the porch. Second below: The noticeboard. Bottom: Trees needing pruning to the south of the choir vestry.*
