## ASBESTOS SURVEY REPORT

| <b>Property Address:</b> | St Guthlac's Church<br>Holbrook Road<br>Knighton<br>Leicestershire<br>LE2 3WB | | |
| <b>Report Number:</b> | 6774-0001-MR | <b>Issue Number:</b> | 1 |
| <b>Type of Survey:</b> | A combination of a management and part refurbishment survey | | |

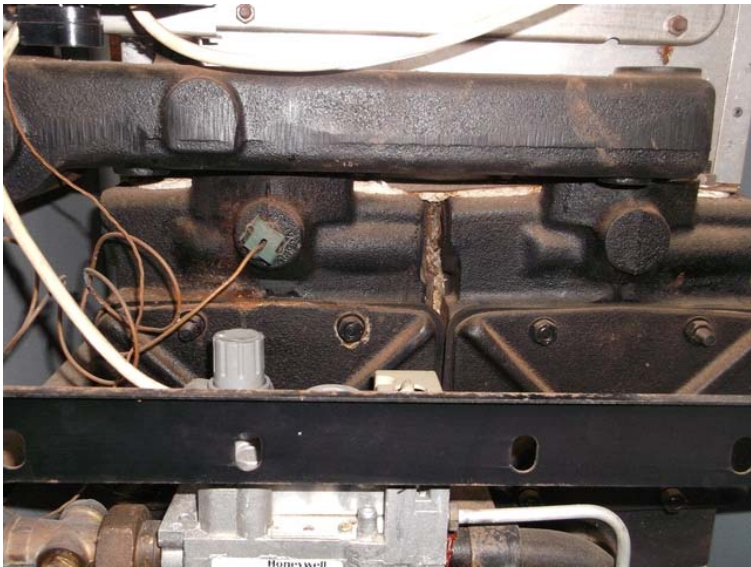
**Photo Reference:** DSCF1488.JPG

| Material Assessment Algorithm | | | | | |
|---|---|---|---|---|---|
| 2-Gaskets | 0-Good condition | 1-Gaskets | 1-Chrysotile | 4 | Very Low |

| | <b>Asbestos type:</b><br>Chrysotile |
| | <b>Potential to release asbestos:</b><br>Very Low |
| | <b>Accessibility:</b><br>Difficult |

| <b>Recommended action</b><br>(in accordance with the Control of Asbestos Regulations 2012) | No action required<br><br>The gaskets are unlikely to give rise to airborne fibre release unless disturbed. However, the gaskets could be disturbed by maintenance workers, therefore it would be advisable to make them aware of the possibility of asbestos containing materials being present before any works are carried out. | | |

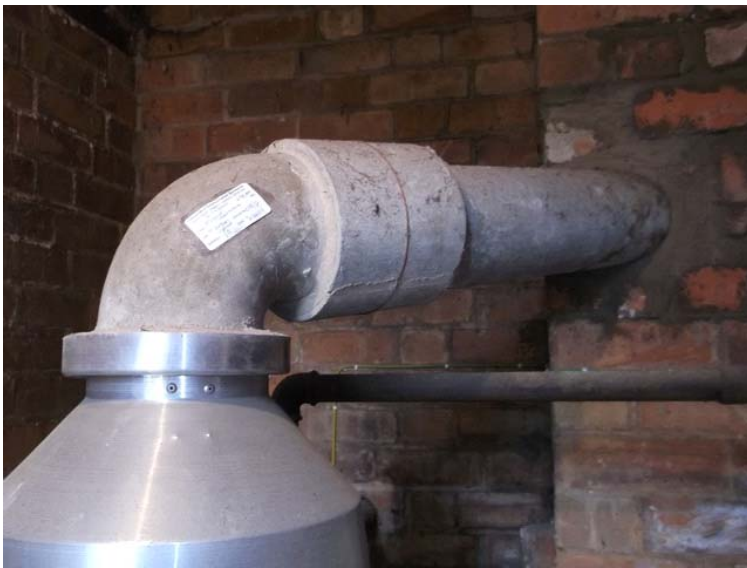
| <b>Photo Reference:</b> | DSCF1489.JPG | | | | |

| Material Assessment Algorithm | | | | | |
|---|---|---|---|---|---|
| 1-Asbestos Cement | 0-Good condition | 1-Cement | 2-Amosite & Chrysotile | 4 | Very Low |

| | <b>Asbestos type:</b><br>Amosite / Chrysotile | | | | |
| | <b>Potential to release asbestos:</b><br>Very Low | | | | |
| | <b>Accessibility:</b><br>Difficult | | | | |

| <b>Recommended action</b><br><i>(in accordance with the Control of Asbestos Regulations 2012)</i> | No action required<br><br>The cement flue is unlikely to give rise to significant airborne fibre release unless disturbed as the asbestos fibres are bound into a hard cement matrix. However, disturbing the flue or subjecting it to mechanical damage (e.g. drilling or sanding) may give rise to airborne fibre release and should be avoided. | | |

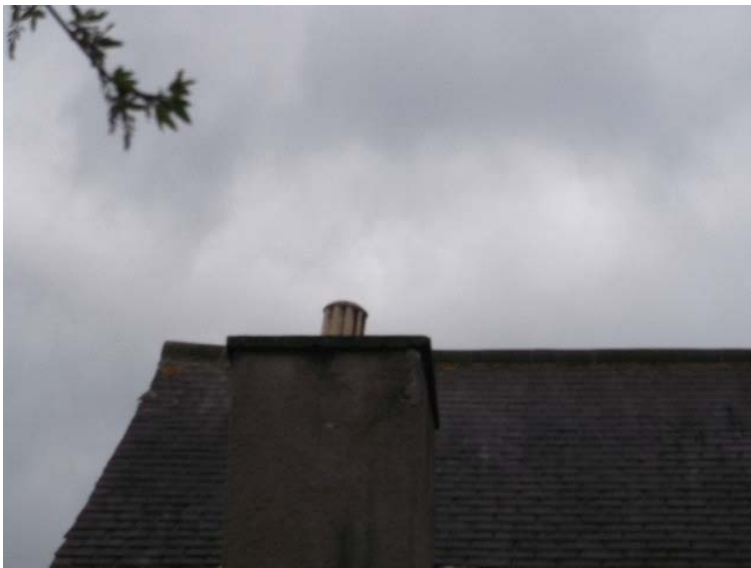
| <b>Photo Reference:</b> | DSCF1490.JPG | | | | |

| Material Assessment Algorithm | | | | | |
|---|---|---|---|---|---|
| 1-Asbestos Cement | 0-Good condition | 1-Cement | 1-Chrysotile | 3 | Very Low |

| | <b>Asbestos type:</b><br>Chrysotile | | | | |
| | <b>Potential to release asbestos:</b><br>Very Low | | | | |
| | <b>Accessibility:</b><br>Difficult | | | | |

| <b>Recommended action</b><br><i>(in accordance with the Control of Asbestos Regulations 2012)</i> | No action required<br><br>The cement cowling is unlikely to give rise to significant airborne fibre release unless disturbed as the asbestos fibres are bound into a hard cement matrix. However, disturbing the cowling or subjecting it to mechanical damage (e.g. drilling or sanding) may give rise to airborne fibre release and should be avoided. | | |
