# **quinquennial inspection**

## **church of st guthlac • leicester**

**pcc of st guthlac • leicester**  
date of inspection: 25 october 2019

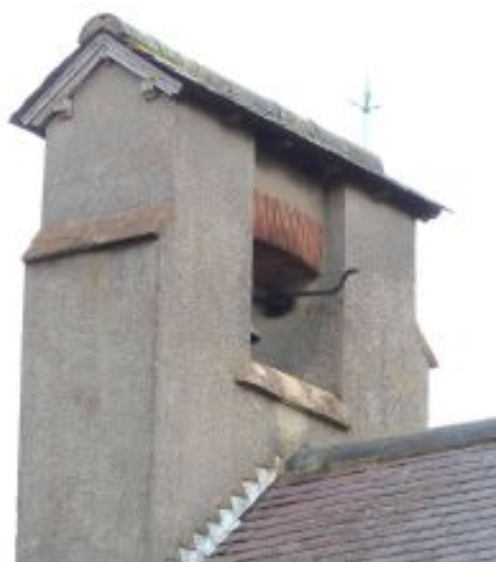
- i The roof is of regularly sized Welsh slates with a clay ridge, which appears to be in a good condition. The slates also appear to be in a good condition.
- ii The bellcote to the west end of the roof is of rendered masonry with brick detailing to the arch. The bellcote is capped by a slate roof covering. The abutment flashings of the roof with the bellcote are all in place, although it appears possible that the soakers are missing from the upper 3 or 4 courses of slates. These are not visible from ground level and this should be investigated to see if this is the cause of the water penetration

Top: Chancel, south slope. Above: Flashings to the bellcote with possible missing soakers. Below: View of the bellcote.

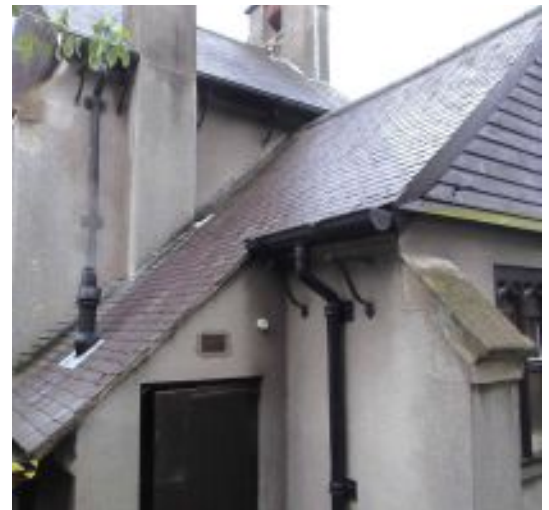
- i The roof is of Welsh slates, which are in a good condition.
- ii There is damp staining against the abutment with the north wall where the water discharges from the chancel roof but this appears to be watertight.
- iii The north east corner of the roof has 2 slates at the eaves that are displaced and should be re-fixed to preserve the integrity of the roof covering. There are also a number of slates higher up the roof at the northern gable that are displaced and also need to be re-fixed.

*Above: Displaced slates to the east end of the chancel north slope. Below: Clergy vestry/boiler room, east slope. Second below: Displaced slates to the north east corner eaves. Bottom: Clergy vestry, west slope and valley gutter.*

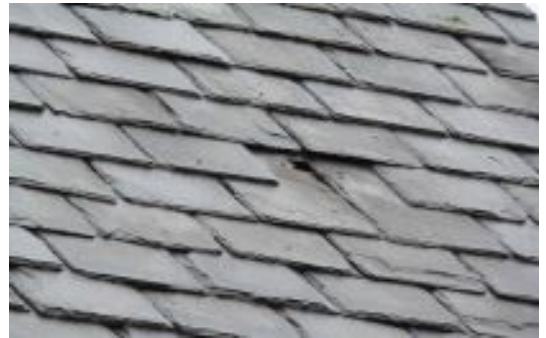
- i The roof is of natural Welsh slates, which are in a generally good condition. One slate is noted to be missing to a corner section and there is one slightly displaced slate towards the central portion of the roof and one missing slate towards the west end of the roof, approximately 3 slates in and 10 courses up and this does need to be replaced quite urgently. There are also 2 ventilation openings, which appear to be redundant and ideally should be replaced when any work is done to the roof but otherwise the roof is in a good condition.
- ii The ridge tiles have a lack of mortar pointing to the tiles of the western 5m and ideally these should be re-bedded, particularly if there is any further sign of movement.

Top: Nave, north slope. Above: Missing slate to the western end of the nave north slope. Below: Nave, south slope. Second below: View of the choir vestry and roof. Bottom: East slope of the choir vestry roof and guttering.

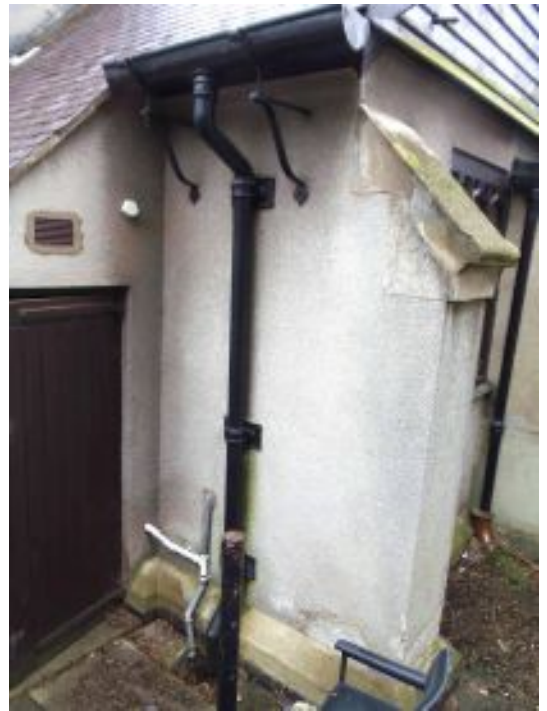
*Above: Downpipe and guttering to the east side of the choir vestry. Below: Chancel, south elevation. Bottom: Chancel, east elevation.*

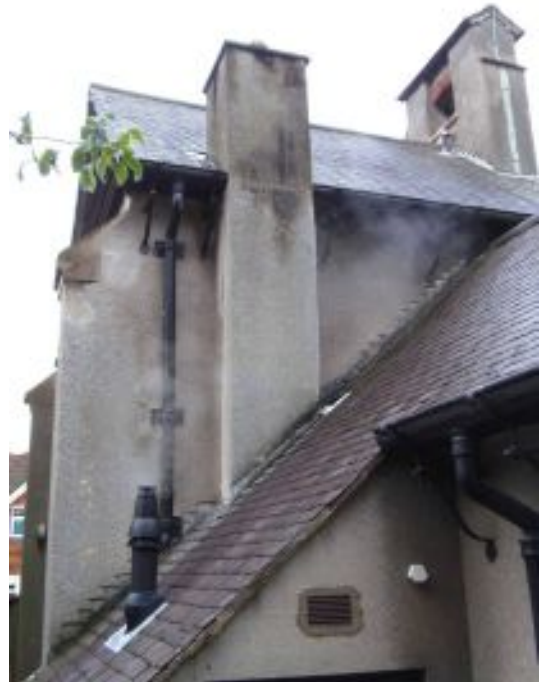
- i The elevation is of rough cast rendered masonry, which is in a generally good condition. There is minor deterioration of the render to the rear of the downpipe but this otherwise appears

- ii There is an abutting chimney, which is rendered with rough cast render and is in a generally good condition, although there is minor deterioration of the render to the northwest corner, which affects an area of approximately 0.3m<sup>2</sup>. There is also slight cracking of the render to the northeast corner indicating there is an area of perhaps 1.5m<sup>2</sup> which is loose. Ideally the crack should be grouted or loose render removed and replaced, but this is a relatively low priority at this stage.
- iii The west section of the elevation is in a good condition. All visible flashings are in place.

*Above: Chancel, north elevation and abutting chimney.  
Below: Boiler room north elevation and timber entrance door.  
Bottom: Timber weather boarding to the top of the clergy vestry north gable elevation.*

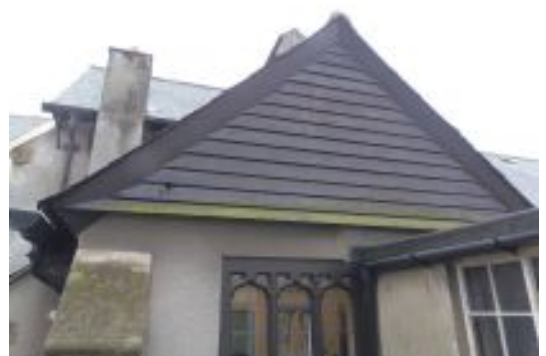
- iv The upper portion of the gable is boarded with timber weather boarding, which is in a good condition, although the lower board exhibits algal growth. Ideally the board should be re-treated with a wood stain to prolong the life of the roof.
- v The gully at the base of the downpipe is in a good condition.

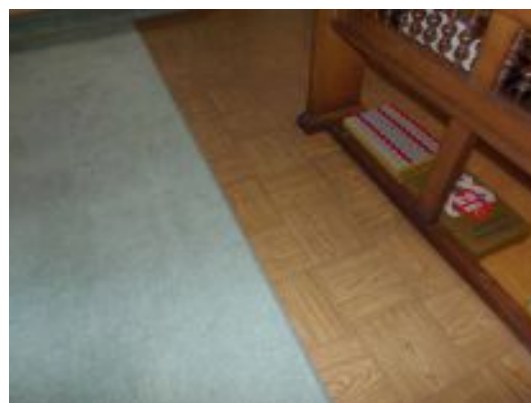
The deflection of the west portion of the chancel floor platform needs to be investigated to ensure it does not form a hazard.

*Above: Altar platform and chancel step. Below: Choir platform, which has some soft patching. Second below: Nave interior looking east. Bottom: Choir vestry interior.*

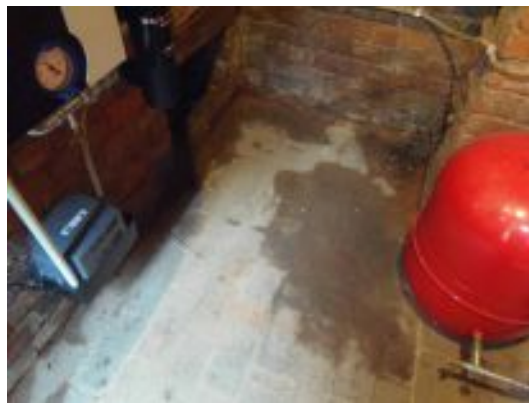
Above: Boiler room floor with some damp. Below: Boiler room steps. Second below: Hardwood entrance door within the porch. Bottom: Chancel north wall through to the vestry.

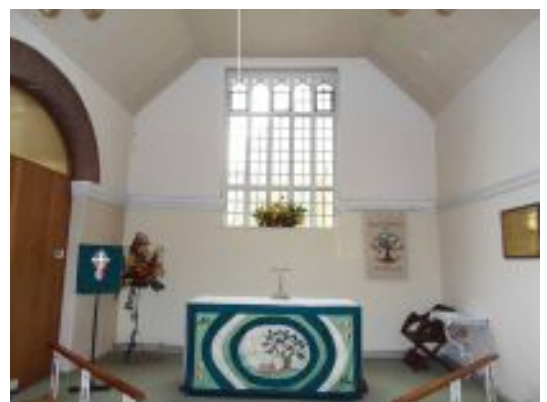
and 5 sub-lights below the window with 3 hopper windows at high level with steel frames, all with leaded glass. The window frames appear to be in a good condition, as does the glazing. There appears to be some deterioration of the putty holding the window glazing in place and this is particularly evident to the north and south sides of the window frames, although the majority of the lower lights appear to be affected. Ideally the putty should be replaced and the windows redecorated.

*Above: Putty failing to the east window frame in the chancel. Below: View of the chancel, east wall. Second below: Chancel, south wall. Bottom: Nave north wall, 2nd bay from west.*

There is minor deterioration of a number of windows, particularly the east window of the chancel, which it would be beneficial to address.

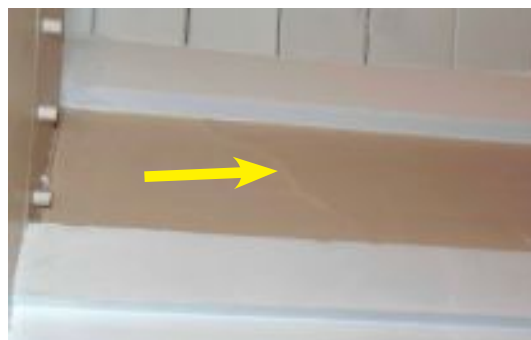
- i The wall is in 4 bays and is of plastered masonry with a stringcourse capping the window openings and timber dado to 1.2m.
- ii The west bay is in a good condition, as is the window opening.
- iii The 2nd bay from west is also in a good condition.
- iv The 3rd bay from west has slight cracking of the plasterwork at high-level, which extends from the upper west corner of the window opening to wall plate level. The cracks are approximately 1mm wide at the widest point and should be monitored for further movement.

v There is further cracking to the stringcourse immediately above the window opening but this is less than 1mm wide and should be monitored for further development.

*Above: Cracking above the western window in the nave north wall. Below: Nave, east wall and chancel arch. Second below: Plaster damage to the north of the chancel arch. Third below: Nave, south wall. Bottom: Cracking above the eastern window on the nave south wall.*

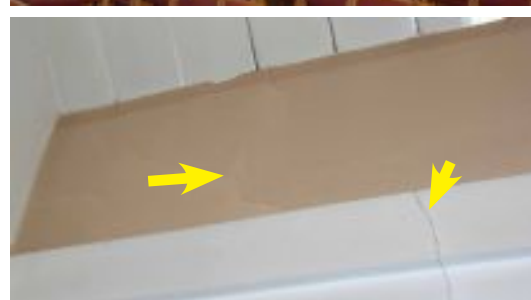
ii The eastern bay has slight cracking to the head of the wall, which emanates from the upper eastern corner of the window and this is about 1mm wide and extends to wall plate height and should be monitored for further movement but otherwise is in a reasonable condition. If repainting is considered any loose plaster should be removed and replaced before repainting. The window opening is in a good condition and the boarding below the window cill is also in a good condition but would benefit from repainting.

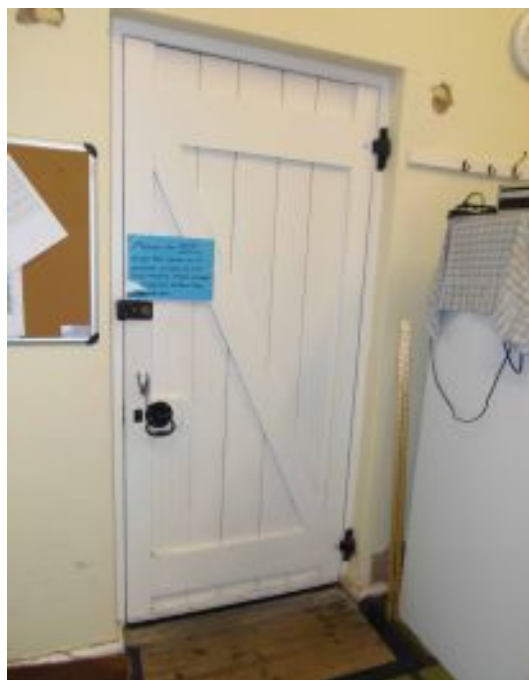
- i The wall is of plastered masonry and is in a generally good condition, although again there has been damage down to the removal of heating pipes, which should be made good and the wall repainted.
- ii The external door is a framed ledged and braced timber door, which is in a good condition internally, as are the built-in cupboards.

*Above: Choir vestry east wall. Below: External door in the choir vestry west wall with some redecoration needed.*

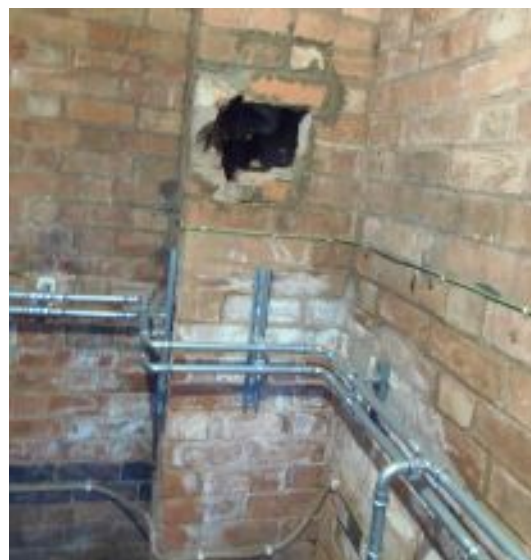
- i The walls are of brickwork and this is in a good condition. There is an open cavity where the flue penetrated the chimney but otherwise this is in a good condition.
- ii At low level there is also a cavity, possibly a coal hole but this is not clear.
- iv The pipework of the fittings within the boiler room is not insulated. It would be beneficial and would protect the room against damage due to frost if the system is ever turned off.
- v The base of the door exhibits minor rot and has expanded slightly and ideally should be adjusted to open and close more effectively.

*Above: Clergy vestry south wall, door through to the chancel.  
Below: Boiler room wall with cavity and un-insulated pipework. Bottom: Boiler room door.*

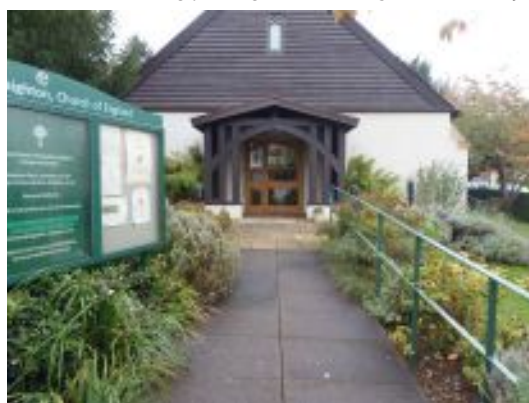
- i To the south of the church there are 5 trees, the eastern of which appears to be a yew tree and all appear to be in a good condition, although it would be beneficial to the church to prune the trees to avoid them damaging the building fabric.
- ii To the west of the church there are 2 trees, the northern of these appears to be a yew tree, which is in a good condition.

*Above: Paved area to west of the church. Below: View of the entrance path to the porch. Second below: The noticeboard. Bottom: Trees needing pruning to the south of the choir vestry.*

Externally the east boundary fence is in a poor condition and needs either to be repaired or replaced. The trees to the east side of the church need to be pruned to ensure that they do

not damage the church during high winds.
