## ASBESTOS SURVEY REPORT

| <b>Property Address:</b> | St Guthlac's Church<br>Holbrook Road<br>Knighton<br>Leicestershire<br>LE2 3WB | | |
| <b>Report Number:</b> | 6774-0001-MR | <b>Issue Number:</b> | 1 |
| <b>Type of Survey:</b> | A combination of a management and part refurbishment survey | | |

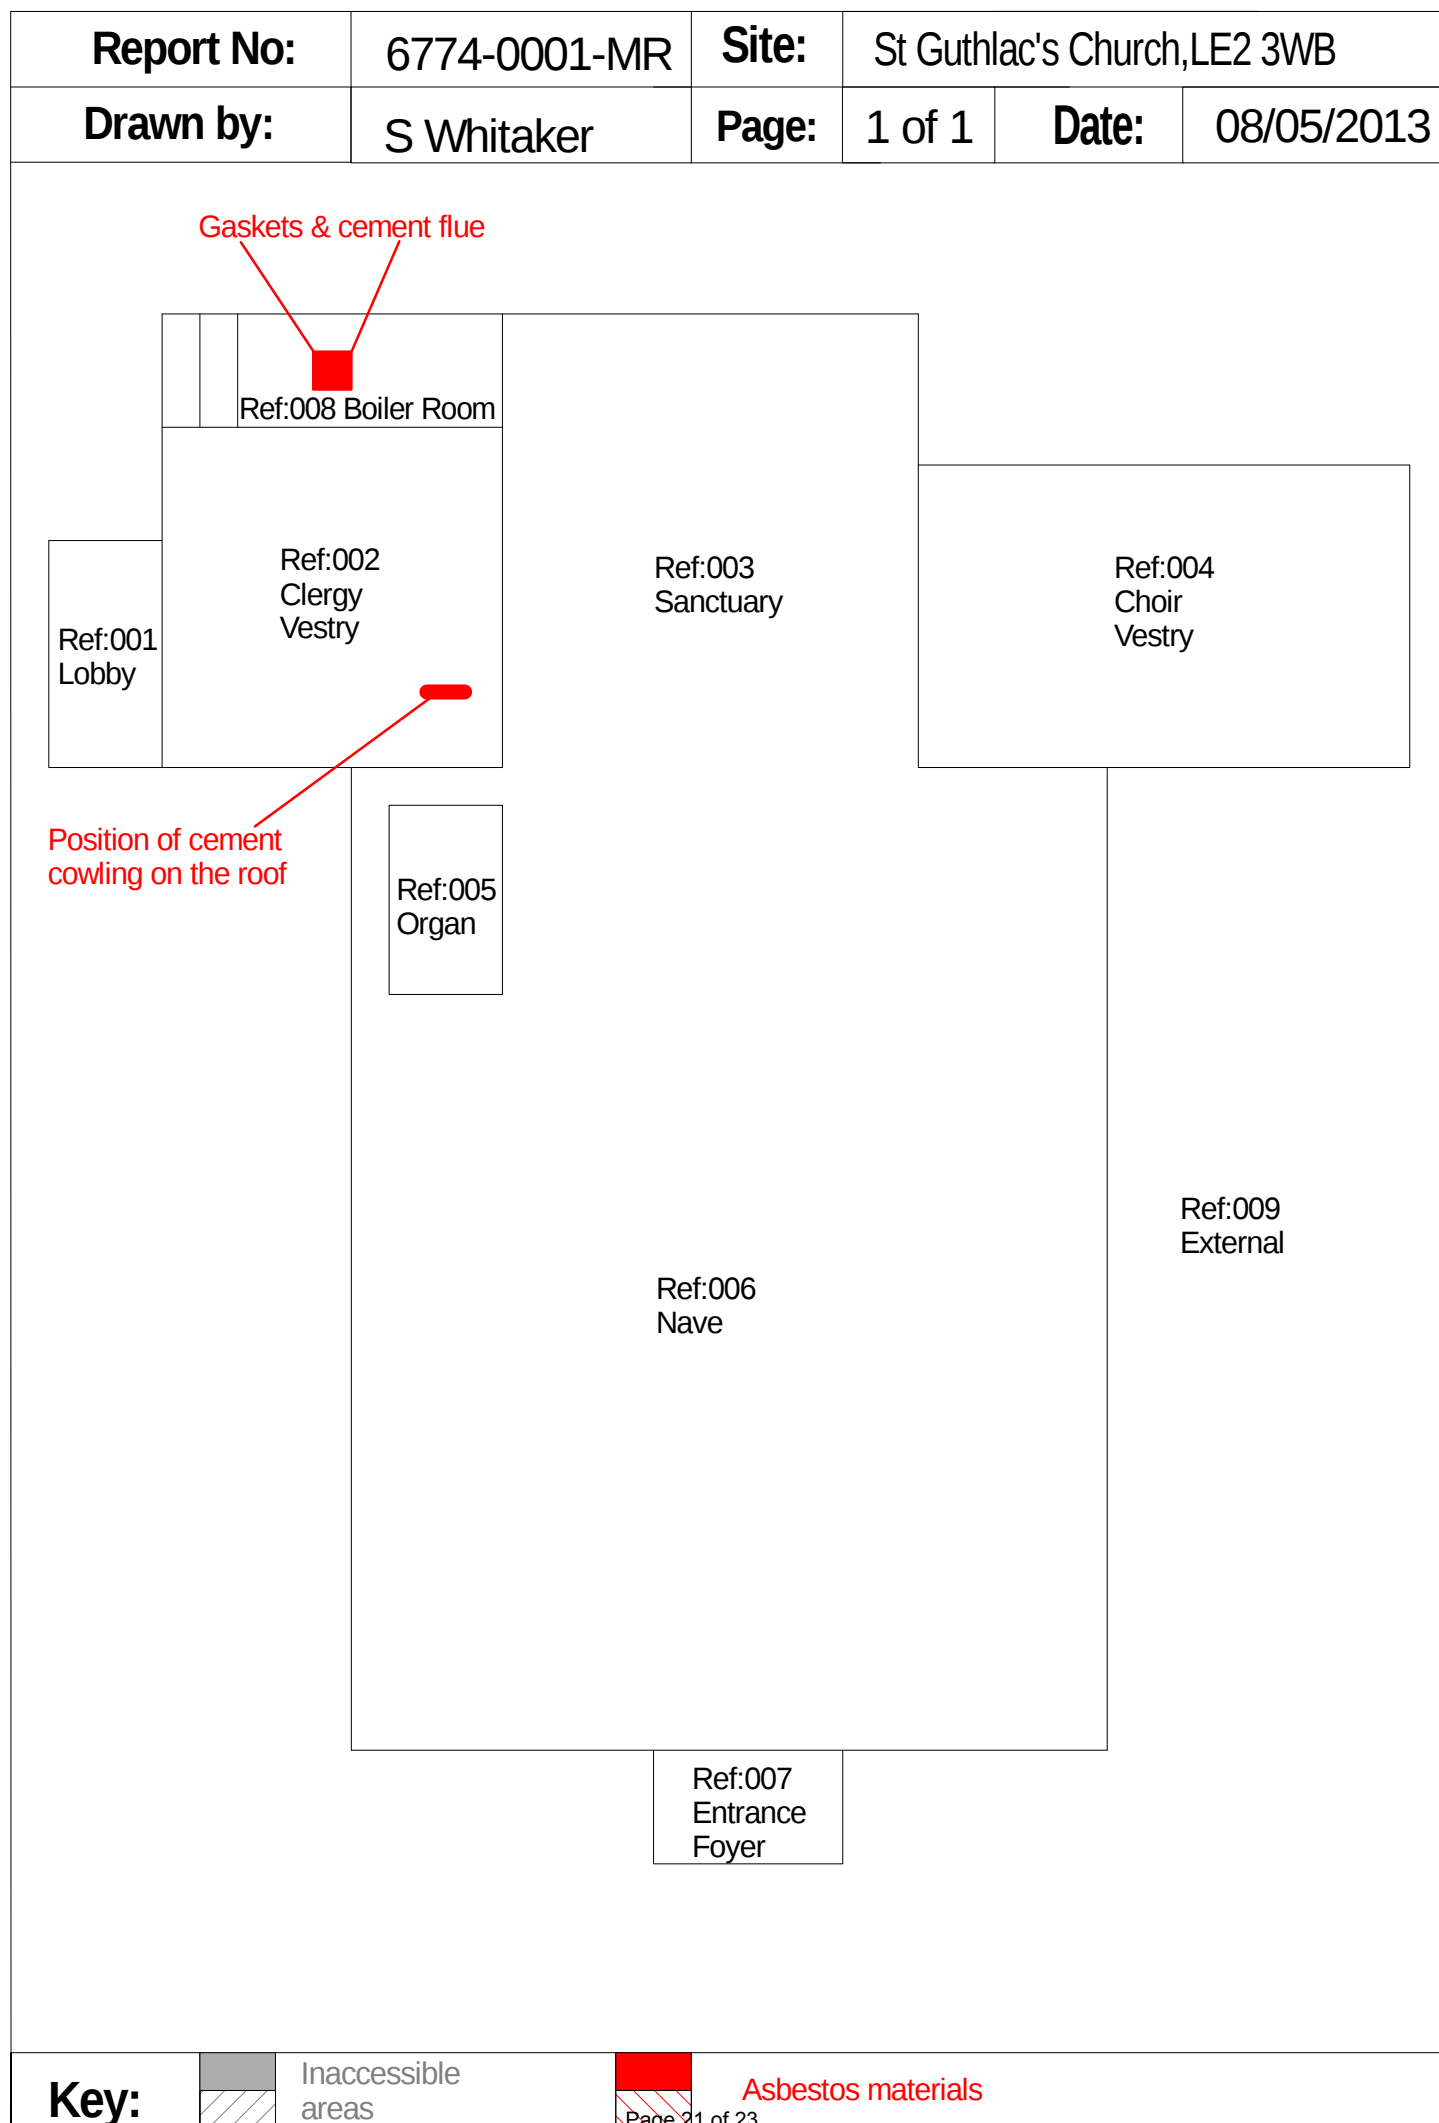
## Appendix B Site plans

A summary of the locations of all asbestos containing materials (ACM's) identified or presumed during the survey along with the action priority and recommended action can be found in 'Section 15.0, Asbestos containing materials' and are highlighted on the site plans in Appendix B.

A summary of all areas and locations that were inaccessible during the survey can be found in 'Section 15.1 Inaccessible areas' and are highlighted on the site plans in Appendix B. These areas / locations should be presumed to contain asbestos on a worst case risk basis until proven otherwise as required by HSG264.
